Manhole Inspection Summary

Manhole # S19AA_012MH

Insp Date: **10/30/07 9:30 AM**

Location Address: **800 PULASKI-BRICE**

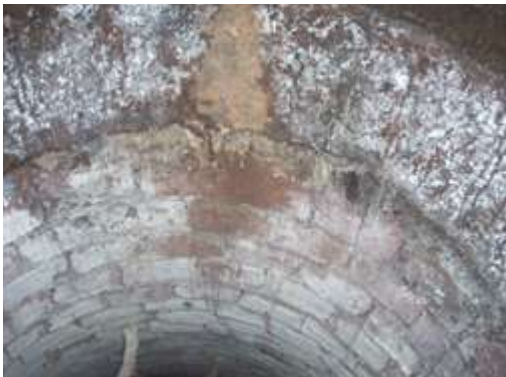
Defect 3

Corbel Material: **Brick** ☐ Parged Type: **Concentric/Eccentric**

Condition: ☐ Sound ☐ Cracked ☐ Root Intrusion ☐ Loose Brick ☒ **Deteriorated**

Infiltration: ☐ None ☒ **Joint** ☐ Cracks ☐ Mortar ☐ Roots ☐ Wall

DETERIORATED CORBEL AND
INFILTRATION

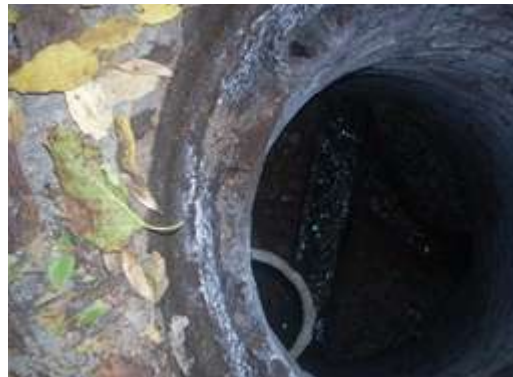
Defect 1

Frame Offset: **1** (in.) Condition: ☒ Sound ☐ Cracked ☐ Leaks

FRAME OFFSET

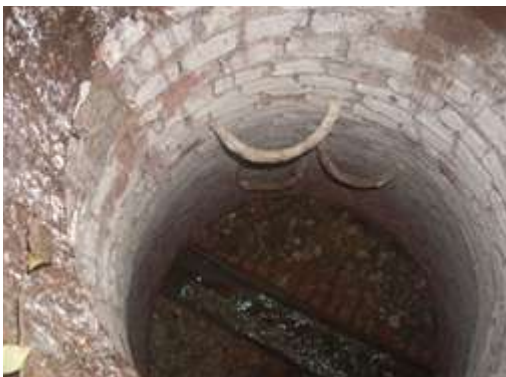
Defect 2

Steps Count: **3** Missing: **0** ☒ **Corroded**

CORRODED STEPS

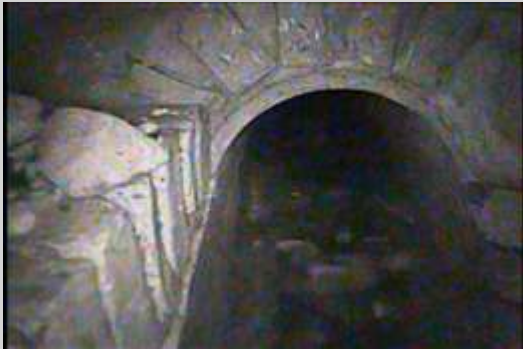
12 O'Clock Outflow

8 in. Circular Gravity Sewer
Pipe Out @ 12 O'Clock

Pipe Height: **8.4** (in.) Rod and Bar (Angled)
Pipe Material: **Clay** ☐ Pipe Lined
Invert Depth: **8.08** (ft.) Flow Characteristics: **Slow**
Deposits: ☐ None ☐ Mud ☐ Sludge ☒ **Debris** ☐ Grease
Silt Depth: **2** (in.) Deposits Extent: **Light**
Infiltration: **None** Pipe Seal Cond: **Sound**
